**VAN HORN PARK UPPER DAM
MA 00574**

**PHASE 1 INSPECTION REPORT
NATIONAL DAM INSPECTION PROGRAM**

JULY 1978

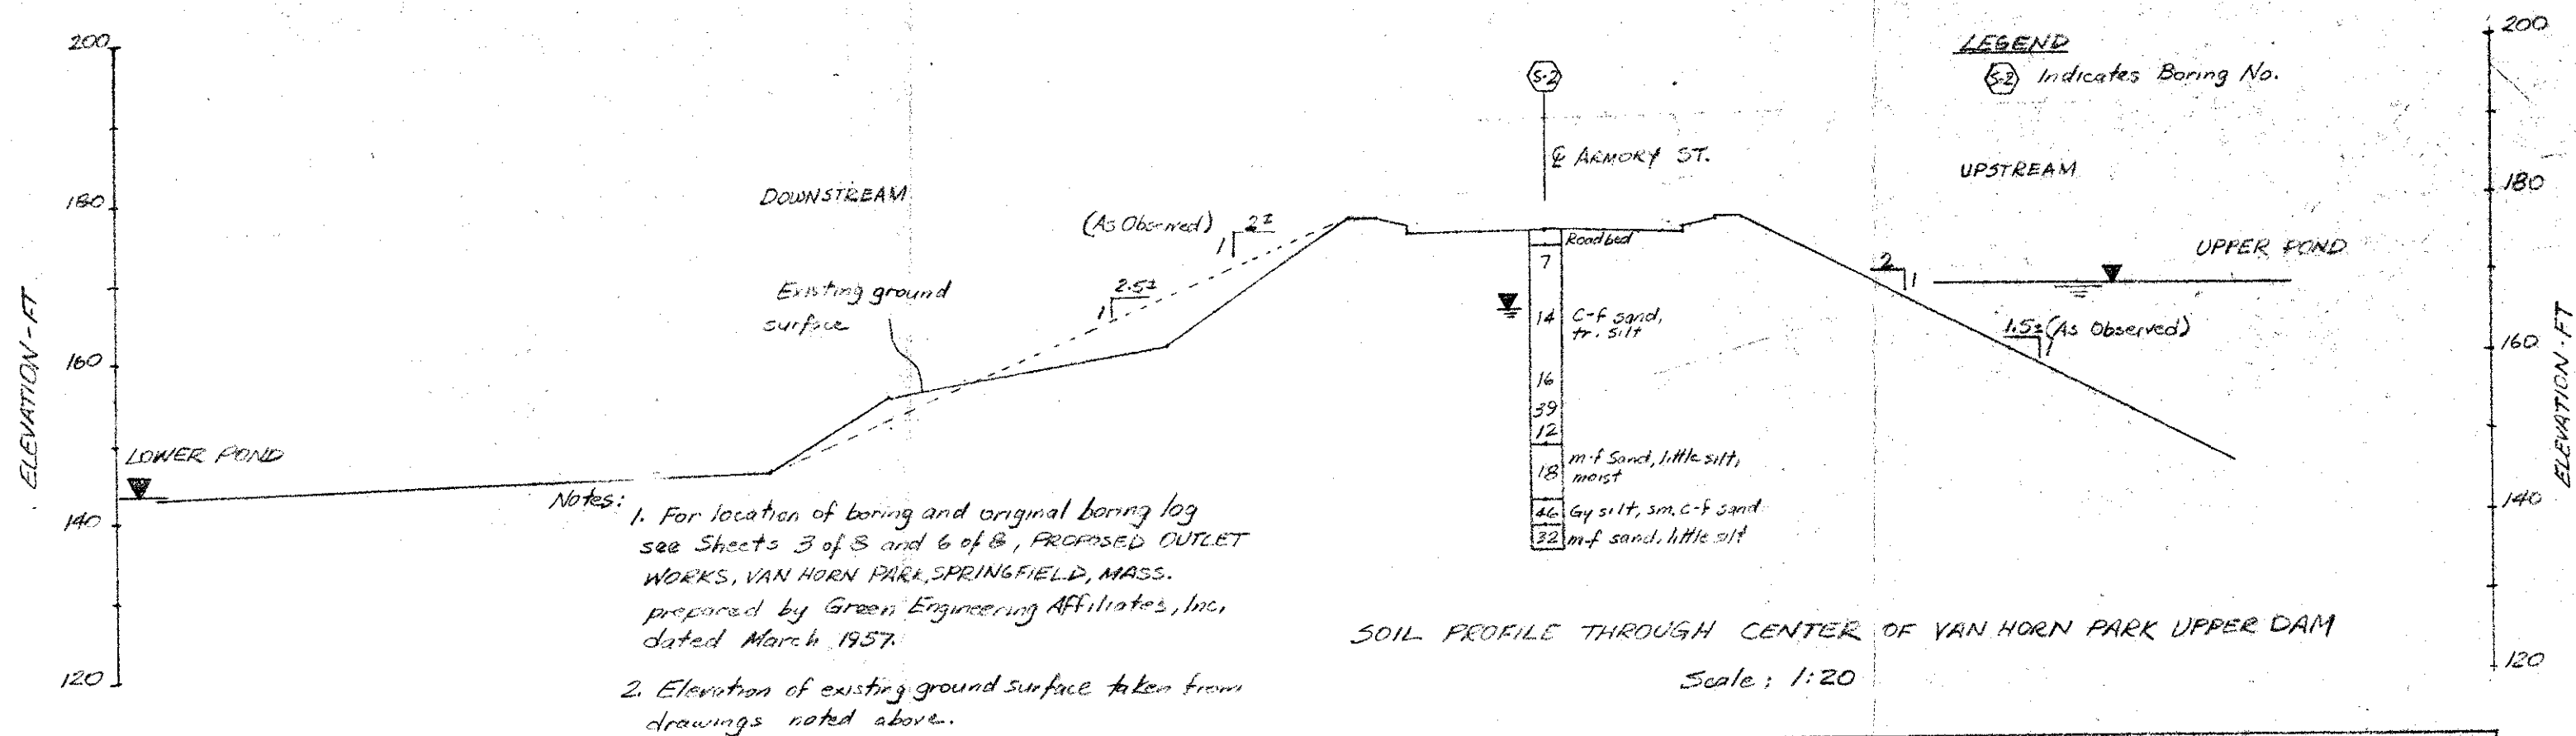
There is minimal information on subsurface conditions obtained from 1 boring drilled for the modification study. The boring log is shown on the drawing given in (b) above. The boring information has been used to develop a soils profile which is shown in the Appendix. There are no test results available from this subsurface exploration program.
